## Determination of radon transmission

SP was requested to measure the radon transmittance through a caulking compound material in accordance with SP Method no. 3873.

The client delivered the material, under the name of Sikaflex PRO-3, to SP Technical Research Institute of Sweden on 2015-02-20. There were no signs of visible damage to the material on arrival. The material was tested without joints on a gypsum board. See Appendix 2 for a picture of the material.

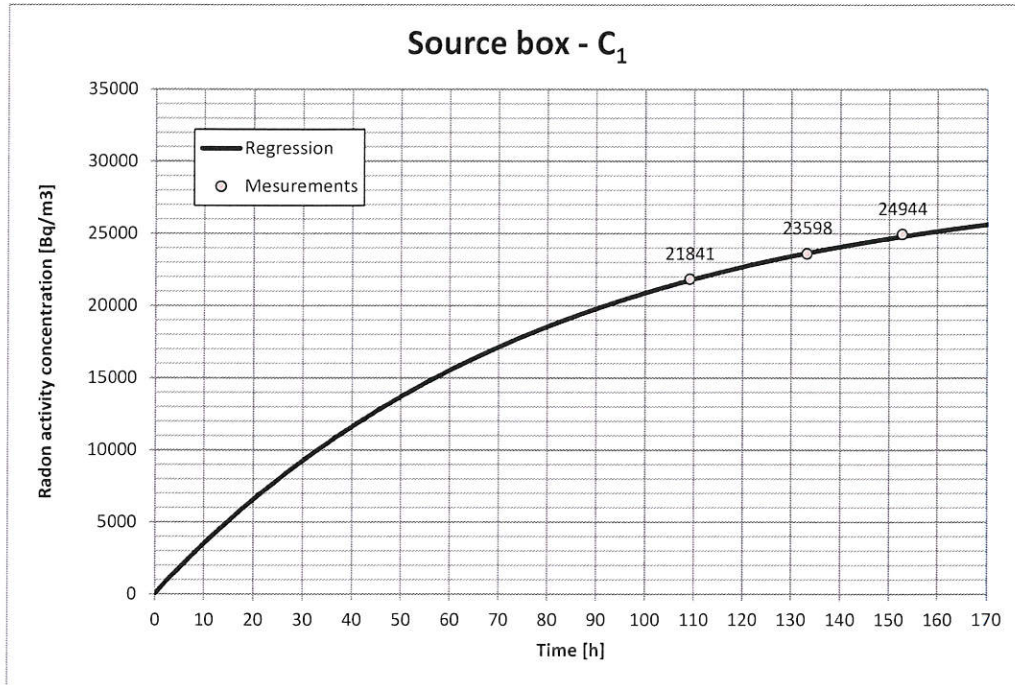
Figure 1 Radon concentration in the primary box: measured daily average values and the regression curve.

by measuring the change in radon concentration on both sides of the test material. Figures 1 and 2 show how the radon concentrations build up in the two boxes.

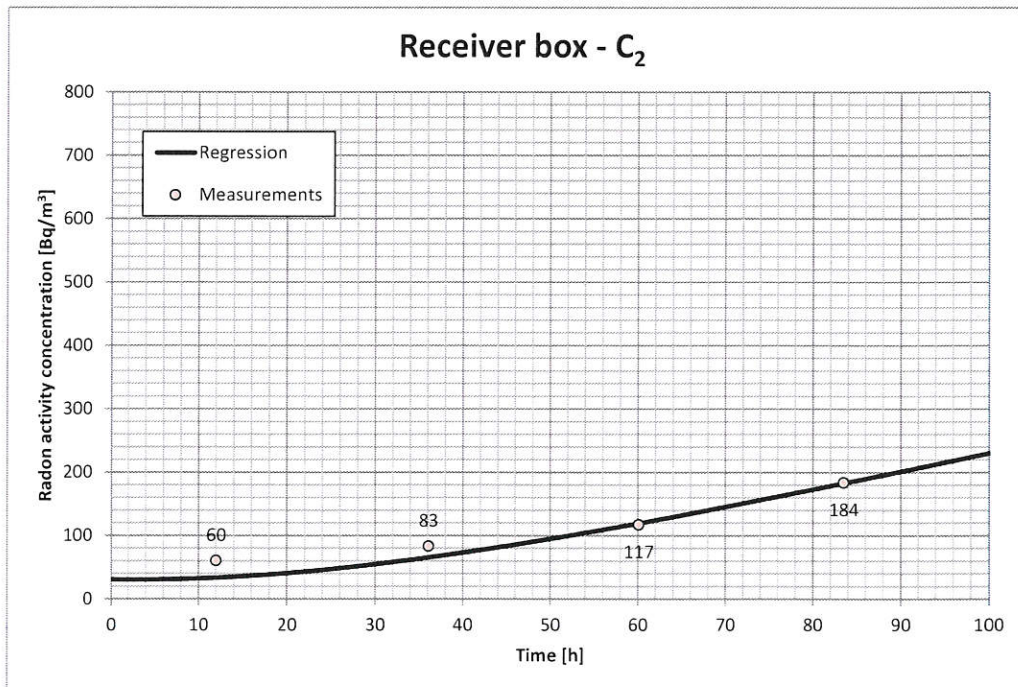
Figure 2 Radon concentration in the secondary box: measured daily average values and the regression curve.

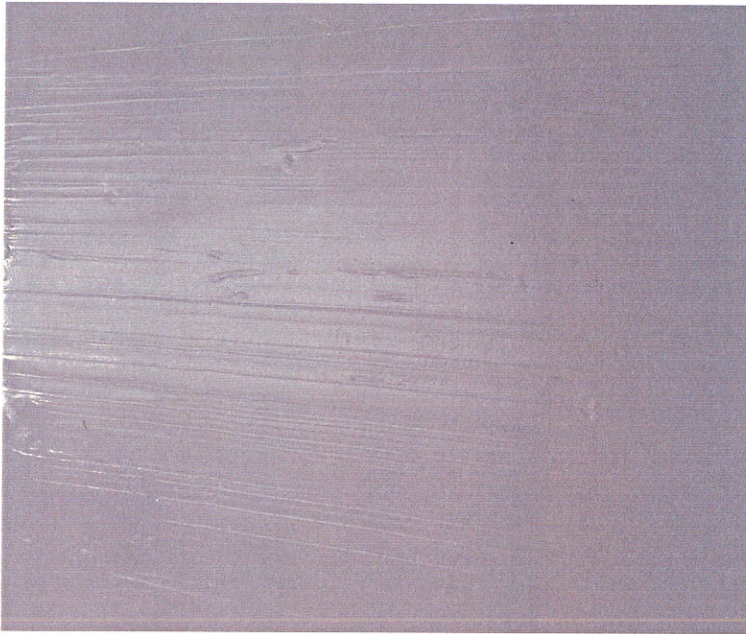
Sikaflex PRO-3
