## Determination of radon transmission

SP was requested to measure the radon transmittance through a caulking compound material in accordance with SP Method no. 3873.

The client delivered the material, under the name of Sikaflex-11 FC+, to SP Technical Research Institute of Sweden on 2015-02-20. There were no signs of visible damage to the material on arrival. The material was tested without joints on a gypsum board. See Appendix 2 for a picture of the material.

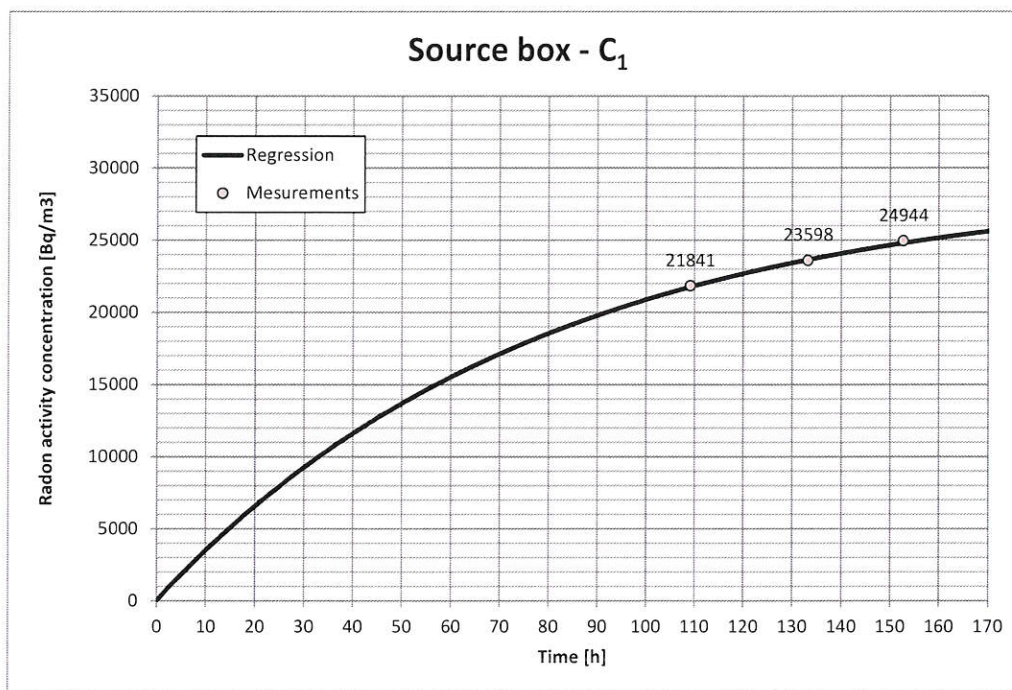
Figure 1 Radon concentration in the primary box: measured daily average values and the regression curve.

by measuring the change in radon concentration on both sides of the test material. Figures 1 and 2 show how the radon concentrations build up in the two boxes.

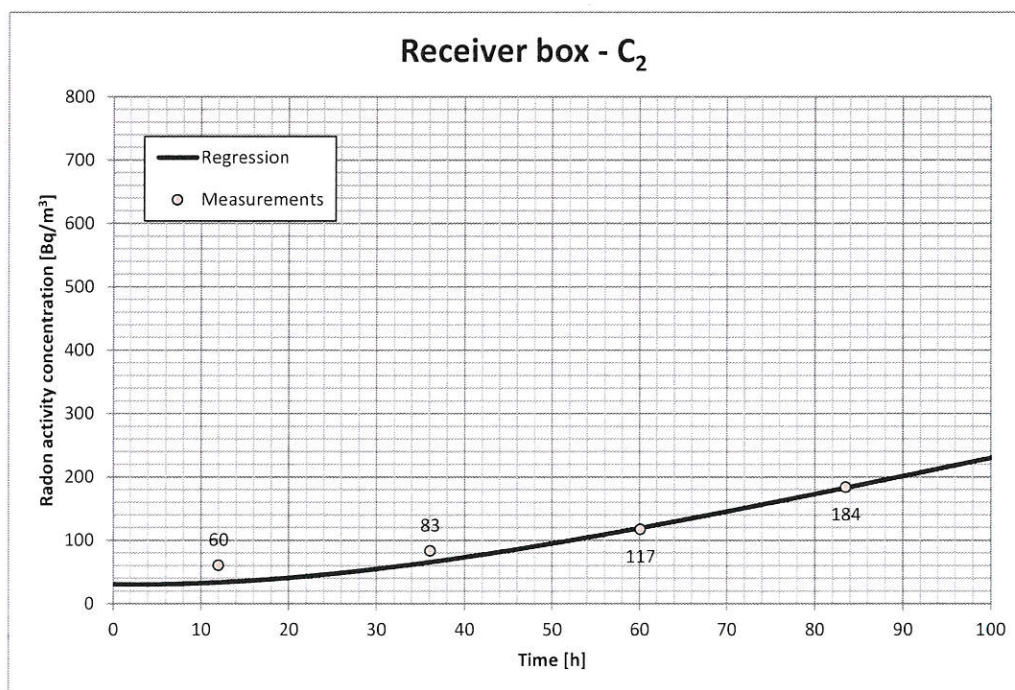
Figure 2 Radon concentration in the secondary box: measured daily average values and the regression curve.

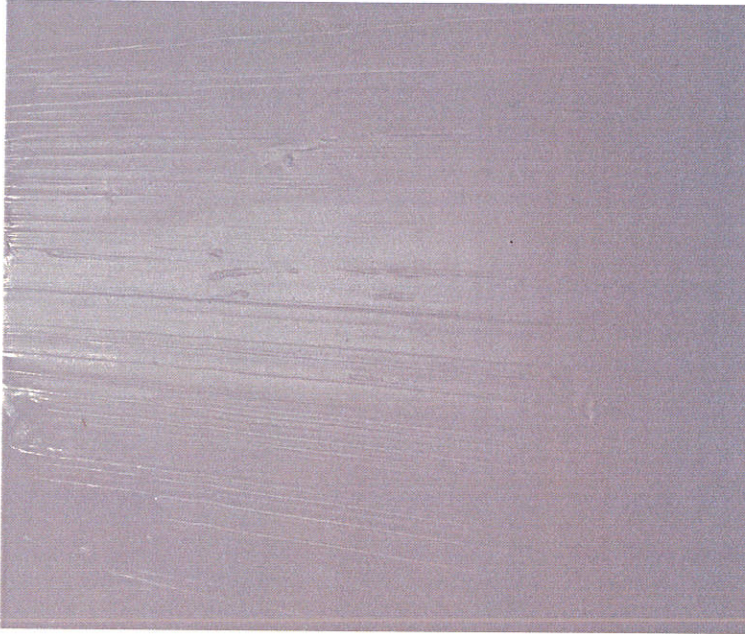
Sikaflex-11 FC+

**Photographs of the tested material**
